EVALUATION OF HYDRAULIC CEMENT CONCRETE OVERLAYS PLACED ON THREE PAVEMENTS IN VIRGINIA

1. Report No. FHWA/VTRC 01-R2		2. Government Accession No.		3. Recipient's Catalog No.	
4. Title and Subtitle Evaluation of Hydraulic Cement Concrete Overlays Placed on Three Pavements in Virginia				5. Report Date August 2000

August 2000
VTRC 01-R2

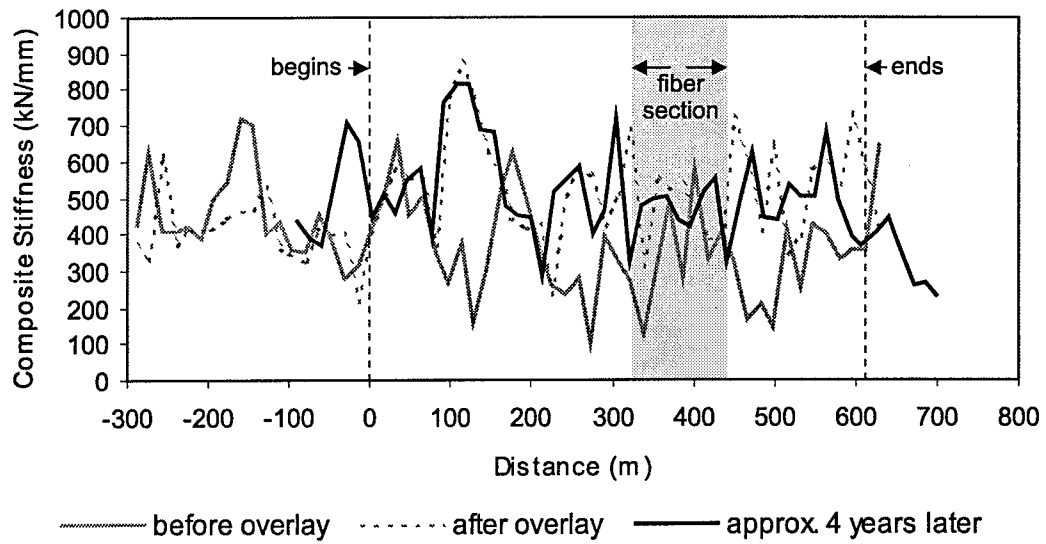
Figure 4. FWD Data of Overlay on I-295 Outside Lane

The composite stiffness of the pavements is shown in Figures 4, 5, and 6. The stiffness was improved with the placement of the overlay. However, the overall stiffness of the Rte. 29 pavement with asphalt and concrete was low because of the presence of the asphalt layer. Figure 7 shows the stiffness of the Rte. 29 inside lane in 1999 with the 6 mm (3 in) white topping. After 4 years, the stiffness of the section with the 51 mm (2 in) white topping was about the same as that initially.
